USAAVLABS TECHNICAL REPORT 66-24

AIRCRAFT FUEL TANK DESIGN CRITERIA

U. S. ARMY AVIATION MATERIEL LABORATORIES
FORT EUSTIS, VIRGINIA
CONTRACT DA 44-177-AMC-254(T)
AVIATION SAFETY ENGINEERING AND RESEARCH
A DIVISION OF
FLIGHT SAFETY FOUNDATION, INC.
PHOENIX, ARIZONA

Technical Report
AvSER 65-17

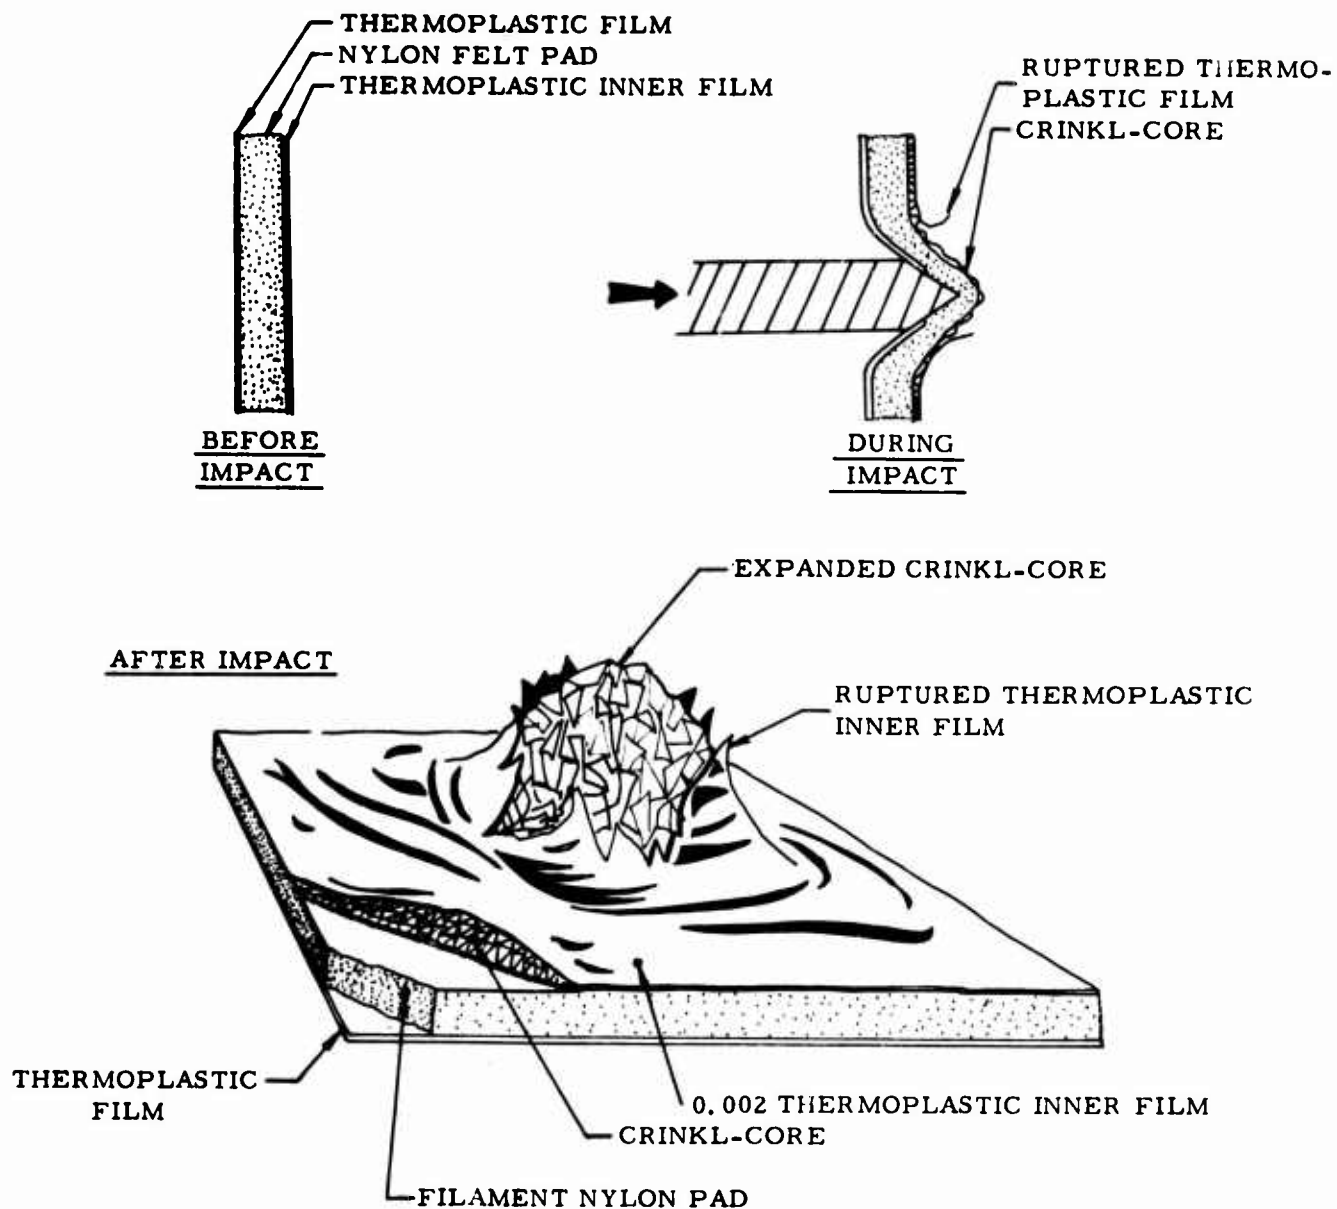
Failure of the felt pad did occur; however, the sealing layer expanded so as to bridge the opening, as shown in Figure 5. The next best material was the four-ply ARM 018 (Specimen H), which took 575 feet per pound with only a small penetration (equivalent to approximately a 1/8-inch-diameter hole). The three-ply A34-10-D (Specimen D) was almost as good but was 12 percent thicker and 27 percent heavier than the four-ply ARM 018 (see Table I).

Figure 5. Operational Principle of Crinkl-Core.

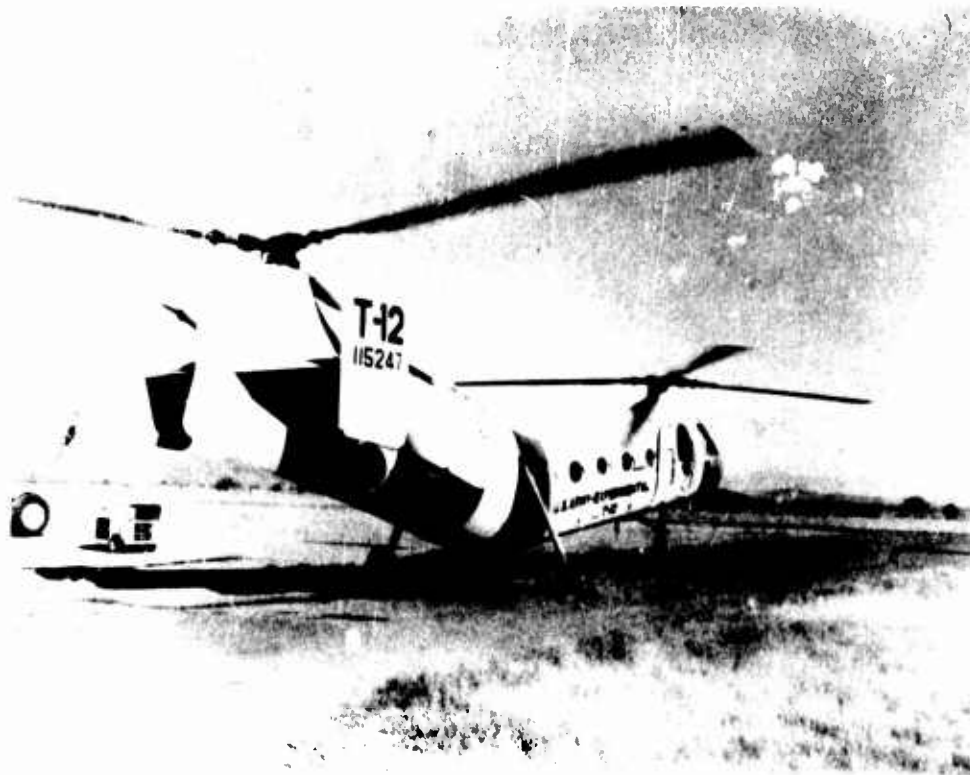
Figure 10. CH-21A Test Helicopter (Fuel Cell Chamber Area Painted Dark Amidships).

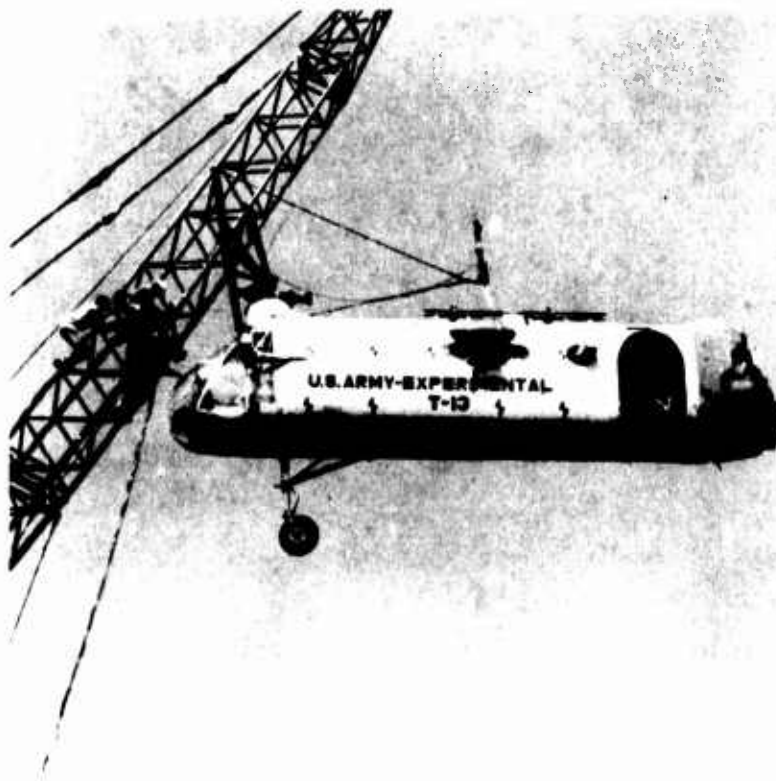
The second test, T-13, was conducted on 22 October 1963 and involved the same test vehicle, the CH-21A shown in Figure 10. The fuselage was separated at the firewall aft of the fuel cell chamber, and the test vehicle for T-13 evolved as approximately two-thirds of the fuselage used in T-12. The fuselage section was dropped from a mobile crane to simulate a crash of greater severity than T-12, the drone flight crash. The test vehicle and crane hookup are shown in Figure 13.

Figure 13. T-13 Helicopter Section and Crane Hookup.

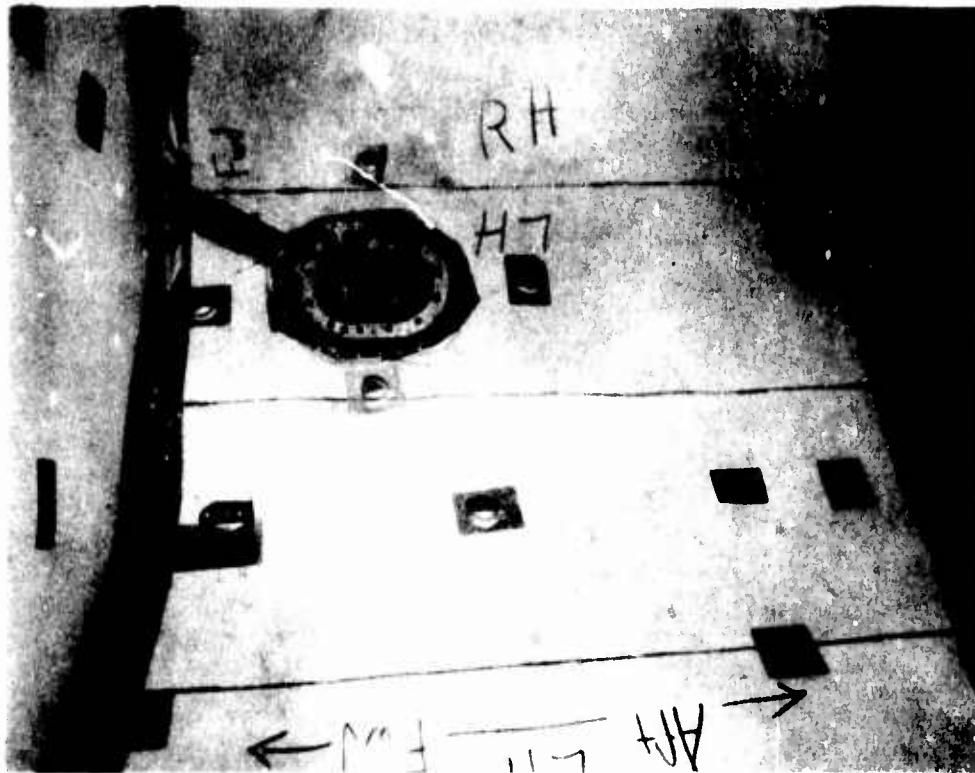
Figure 14. Chamber Bottom Liner Installation.

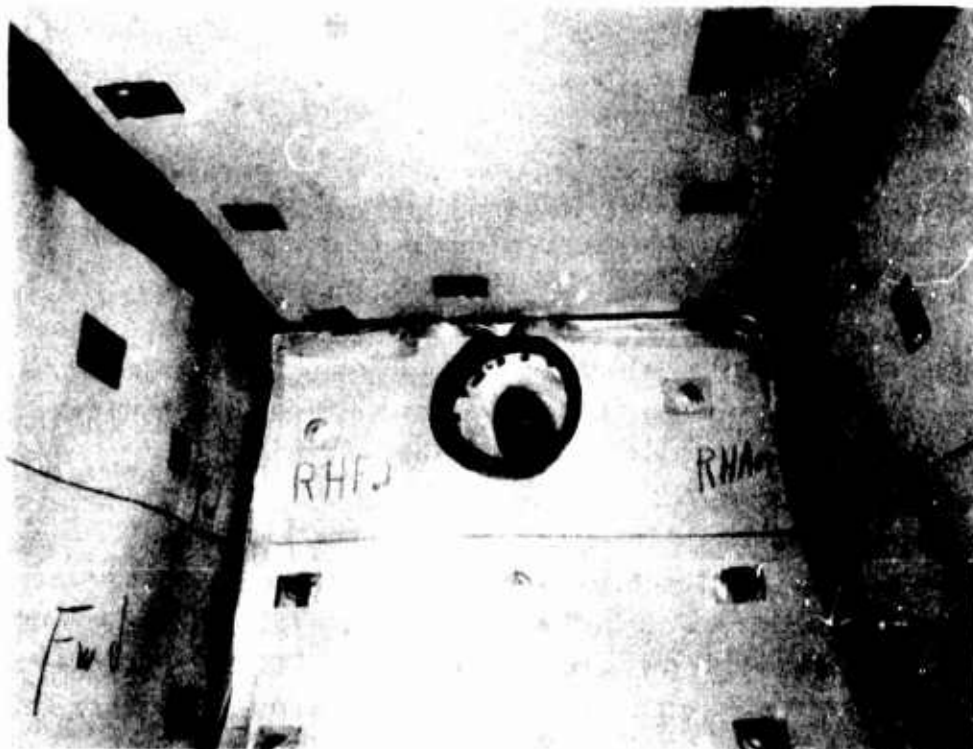
Figure 15. Right Side View of Liner Installation.

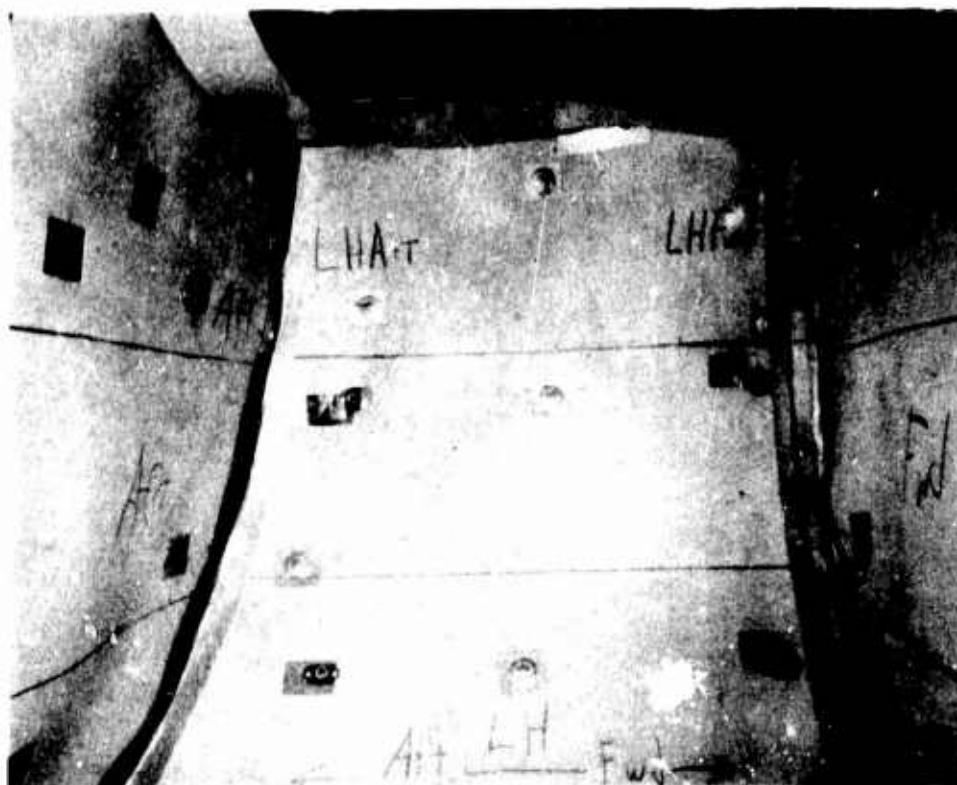
Figure 16. Left Side View of Liner Installation.

The fuel cell was installed after the liner, but structural deformation and the liner installation precluded securing 5 of the 31 fasteners to the chamber top and upper sides.

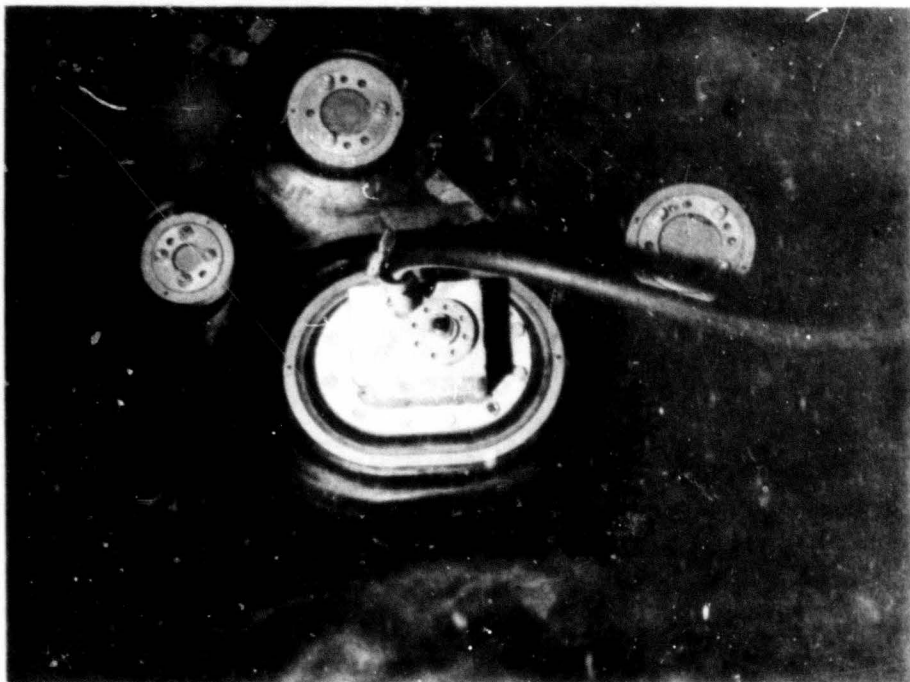
Instrumentation installation was accomplished by fabricating a liquid-tight aluminum housing in the bottom of the bladder cell. All fuel service lines and pumps were removed, and the instrumentation housing was installed in the cavity normally occupied by the booster pump, as seen in Figure 17. Connecting wires to the instruments were run through a 6-foot rubber hose that attached to the top of the instrument housing and exited through the vent installation opening on top of the fuel cell chamber. Sufficient slack was allowed in the hose to prevent line rupture from liquid impact surges.

Figure 17. Instrumentation Mounting in Fuel Cell.

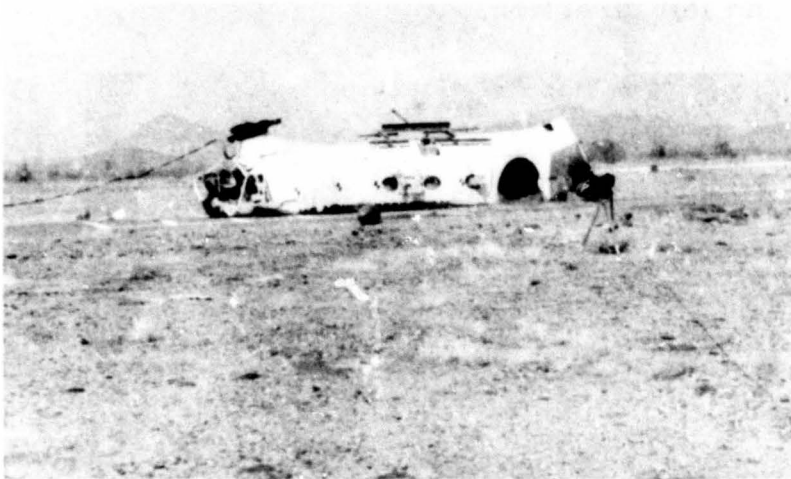
Fuel spillage, as seen in Figure 25, subsided to ground level, spread, and soaked the impact area in the pattern shown in Figure 26.

Figure 25. Helicopter Section at Rest After Skid.

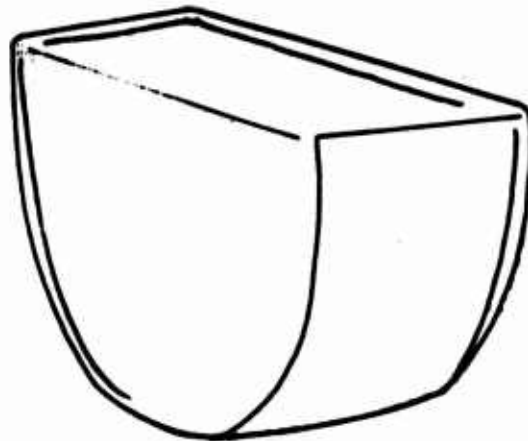
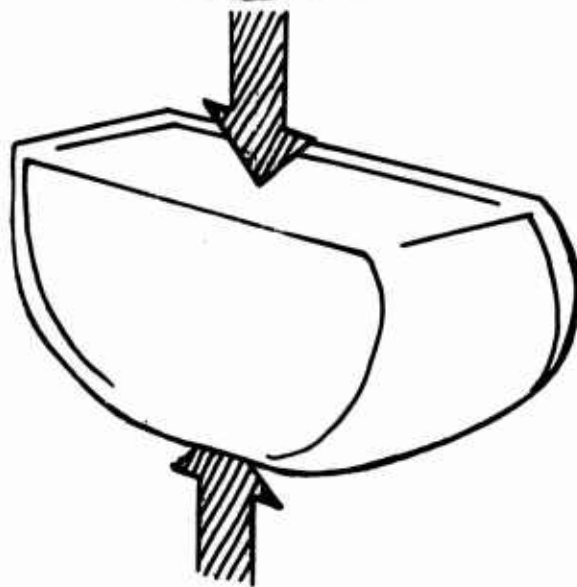
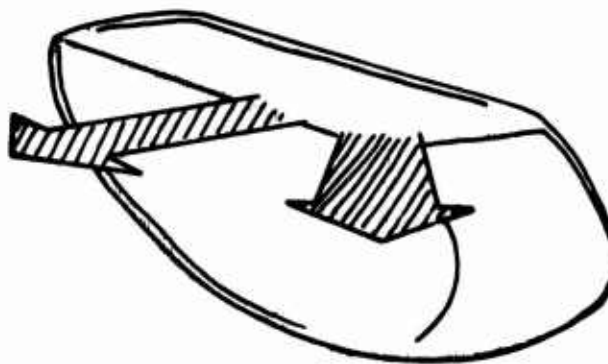
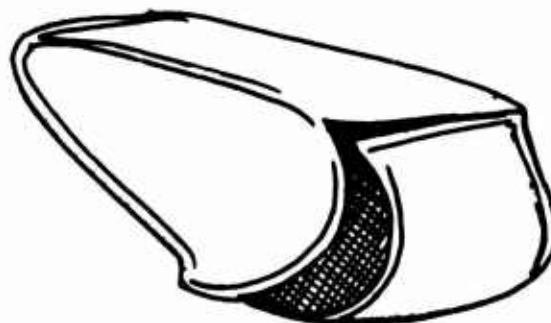
Figure 35. Fuel Cell Rupture Sequence.

Figure 35 is a kinematic sketch that depicts the fuel cell rupture resulting from the impact compression force, primarily in a forward and left direction.

1. The crash resistant bladder cell is considered virtually ineffective as a crash fire deterrent in any crash wherein the supporting structure's failure is severe enough to establish a jagged metal environment.
2. The fuel cell might possibly withstand the impact forces normally encountered during a survivable-type crash if afforded the protection of a flexible seam-bonded liner, such as "wingboard", to enclose it and protect against puncture damage.

3. Airframe structural strength factors surrounding the fuel cell area(s) must be upgraded to prevent:

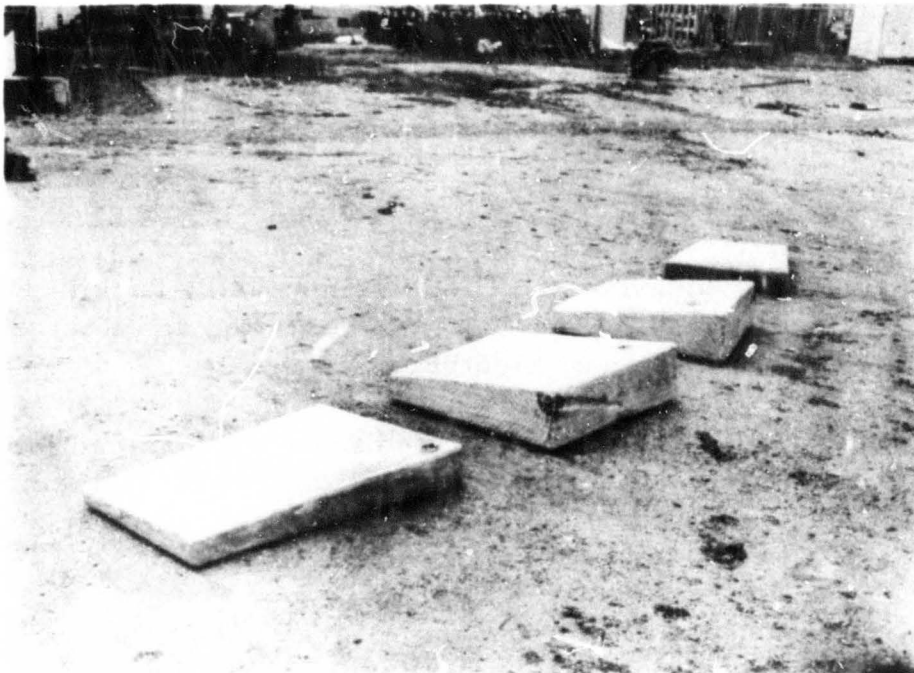
Figure 44. The Four Experimental "Tough Wall" Fuel Tanks, T-19. (The Small Tanks at Each End are Hollow; the Two Inboard Tanks are Honeycomb Filled.)

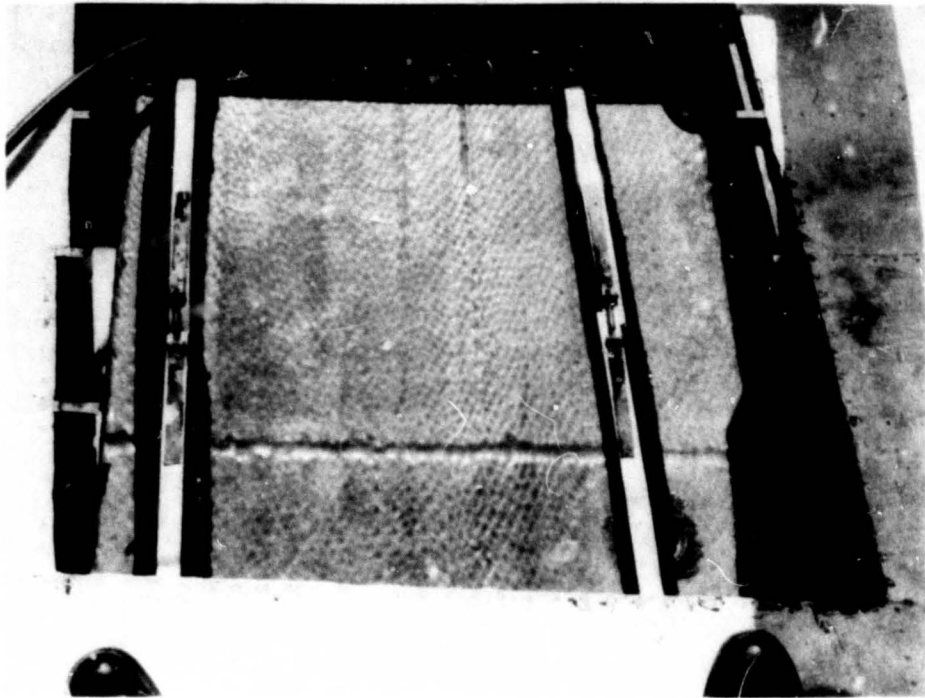
Figure 45. Honeycomb-Filled "Tough Wall" Tank in Place, T-19. (The Tank Was Installed and Restrained in Typical Lightplane Manner.)

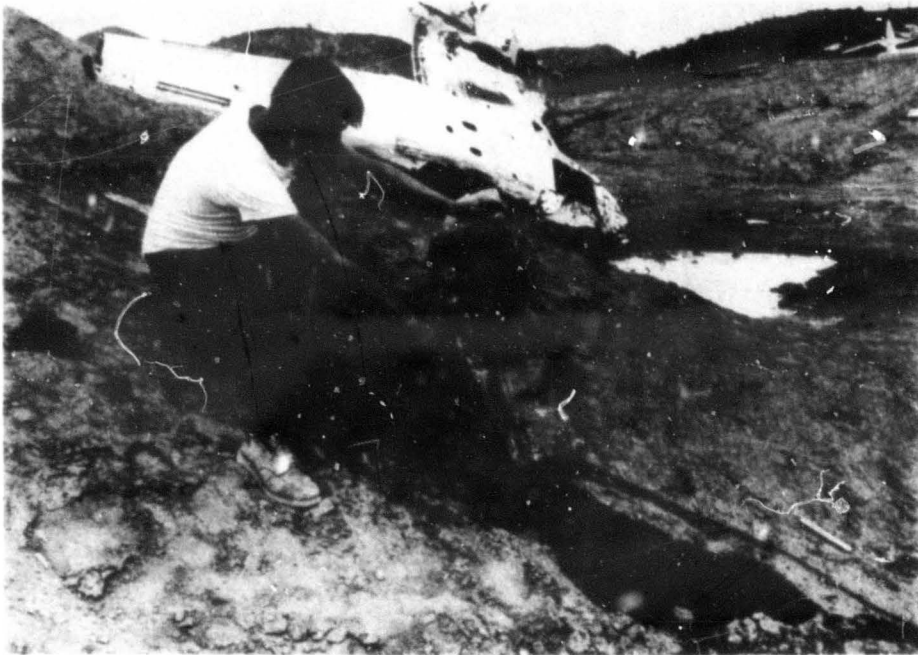
The right wing was separated from the aircraft just outboard of the engine nacelle as it impacted the telephone poles. The inboard honeycomb-core tank was located at the point where the wing separated from the rest of the aircraft and received a direct blow from the telephone pole. Upon separation of the wing, the tank broke through the opening in the wing structure and traveled a distance of approximately 20 feet from the pole, coming to rest on the side of the hill. The only tank damage experienced was a cut of approximately $3/4$ inch in length in the forward face of the tank. Figure 48 shows this tank in its final resting place.

Figure 48. The Right Inboard Fuel Tank, T-19. (Photograph Taken 1 Hour After Impact.)

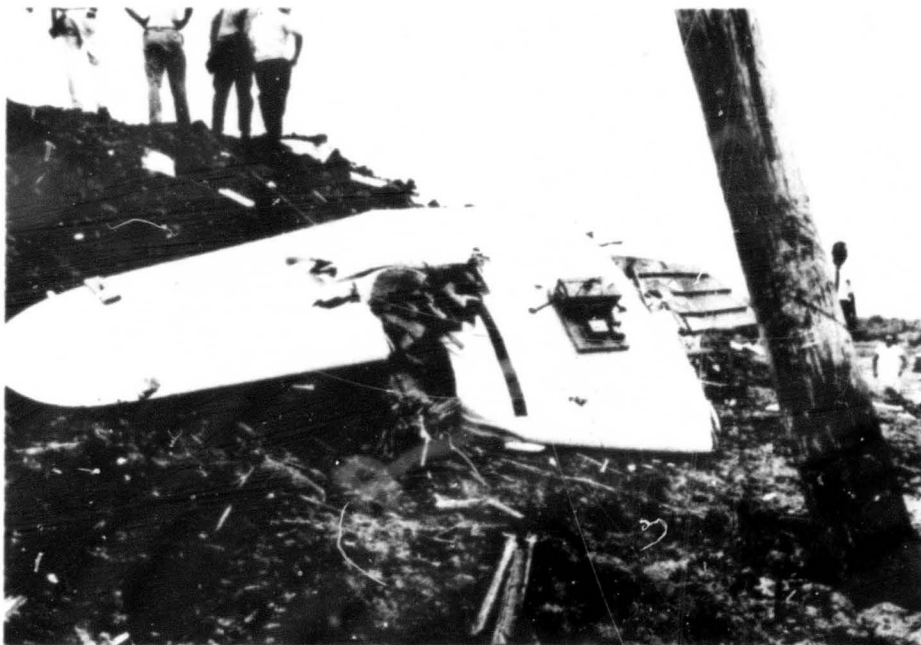
The separated portion of the wing is shown in Figure 49. This portion of the wing contacting the pole was displaced rearward approximately

Figure 49. Pole Impact - Right Wing, T-19.

one-half of the wing chord. The telephone pole struck the center of the experimental tank, which deformed within the wing and finally bulged both the top and bottom of the wing structure outward. The tank experienced one minor pinhole-type penetration, resulting in a very slow seepage after the crash. The tank and deformed structure are shown in Figure 50.

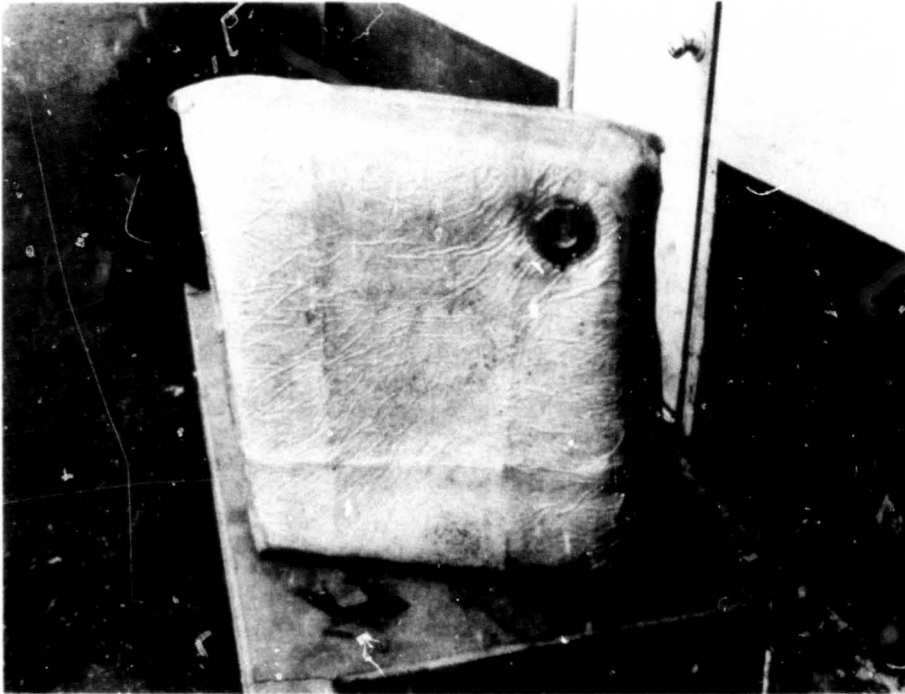
Figure 51. Experimental "Fuzzy Wall", T-24. (The Nylon Felt Tank with the "Crinkl-Core" Interliner Was Covered with a Thin Thermoplastic Film To Prevent the Felt from Functioning as a Wick Should It Become Soaked with Fuel.)

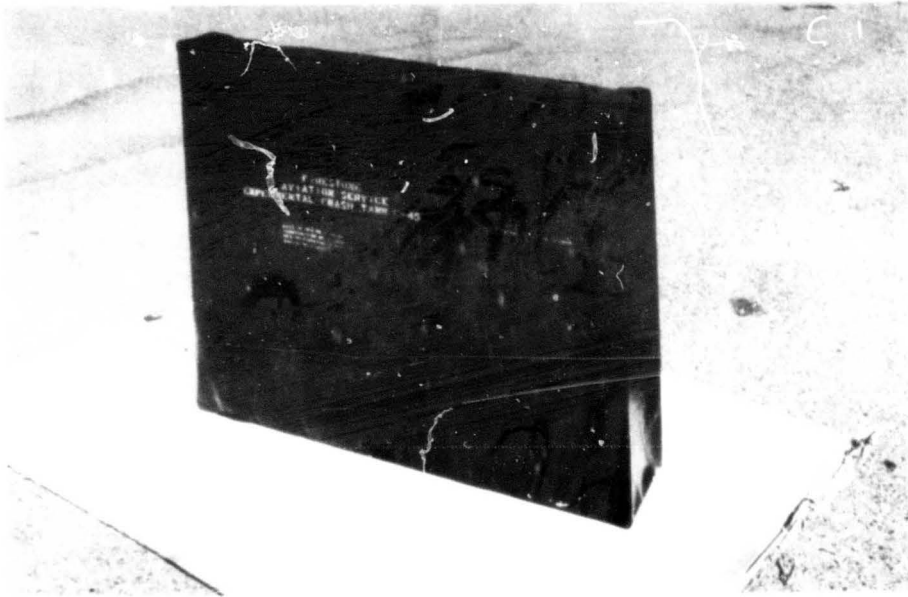
Figure 52. Experimental Sponge-Filled Tank, T-24.
(This Laminated Synthetic Cloth Tank Was
Filled with Open-Pore Sponges To Help
Dampen Fluid Sloshing and To Retard Fluid
Spillage Through a Tank Failure.)

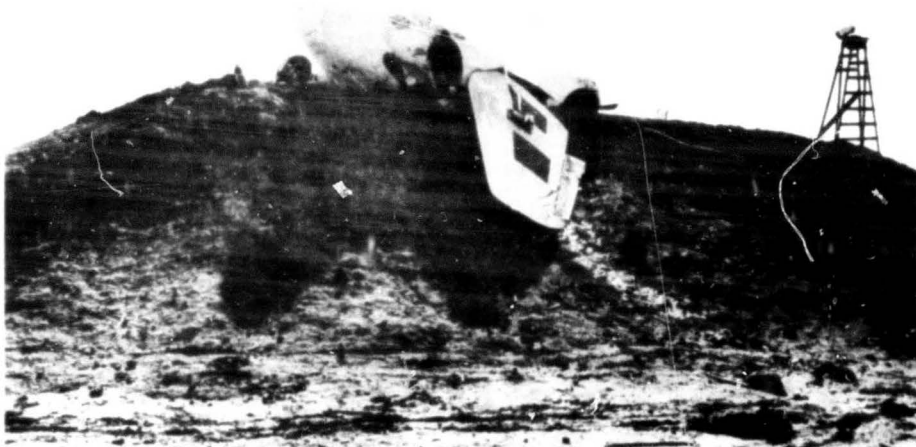
The velocity at the point of impact was approximately 80 mph. At impact with the wing barriers, the right wing was again separated just outboard of the engine nacelle, as shown in Figure 53. The left wing was partially separated just outboard of the engine nacelle and can be seen still attached in Figure 54.

Figure 54. Postcrash View, Left-Hand Side, T-24. (The Left Wing Nearly Separated from the Aircraft at Hill Impact.)

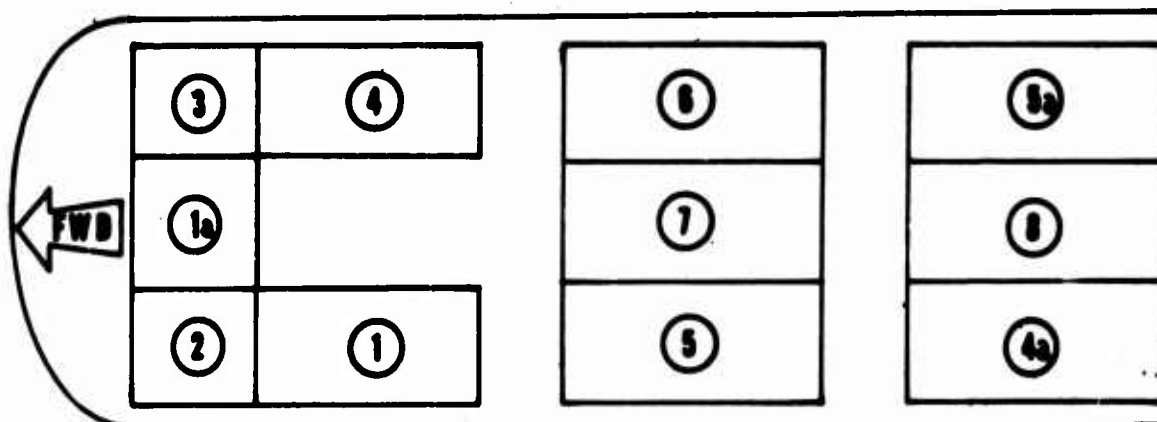
Figure 56. Fuel Cell Type and Location, T-17.

CODE	TANK	CORE	CONTENTS	TANK COMPOSITION
1 and 1a	Self-Sealing	Hollow	Water	Standard
2	Self-Sealing	Hollow	Rigid Gel Gasoline	Standard
3	Self-Sealing	Honeycomb	Water	Standard
4 and 4a	"Tough Wall"	Honeycomb	Water	Specimen D, Nylon Cloth/Polyurethane Resin
5 and 5a	Pliocell	Hollow	Water	Standard
6	Pliocell	Hollow	Rigid Gel Gasoline	Standard
7	"Tough Wall"	Hollow	Water	Specimen D, Nylon Cloth/Polyurethane Resin
8	Aluminum	Hollow	Water	6061-T4

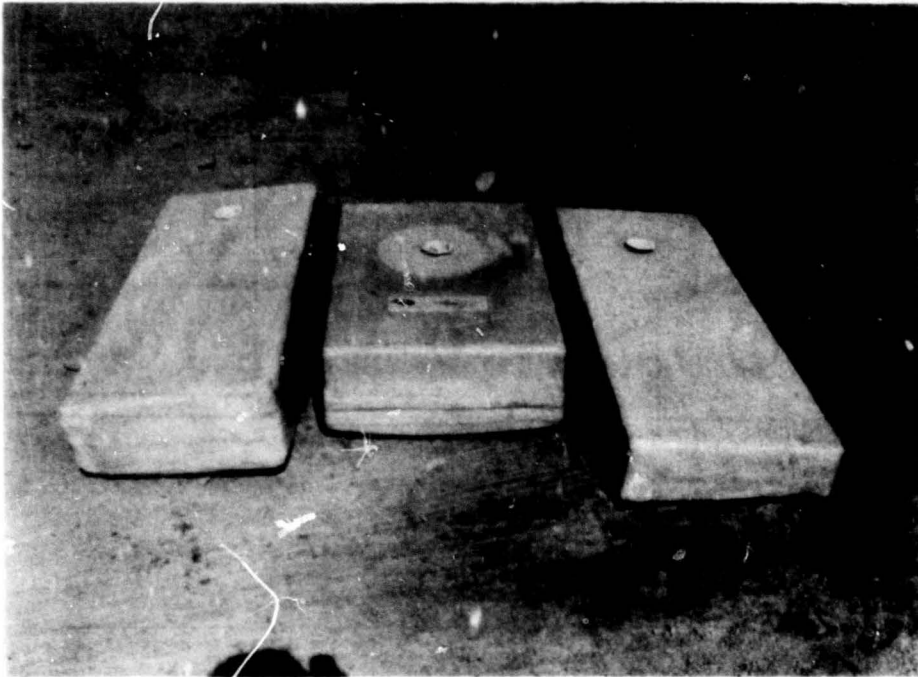
Figure 57. Experimental "Tough Wall" Tanks, T-17. (The Middle Tank Is Hollow, While the Other Two Are Honeycomb-Filled.)

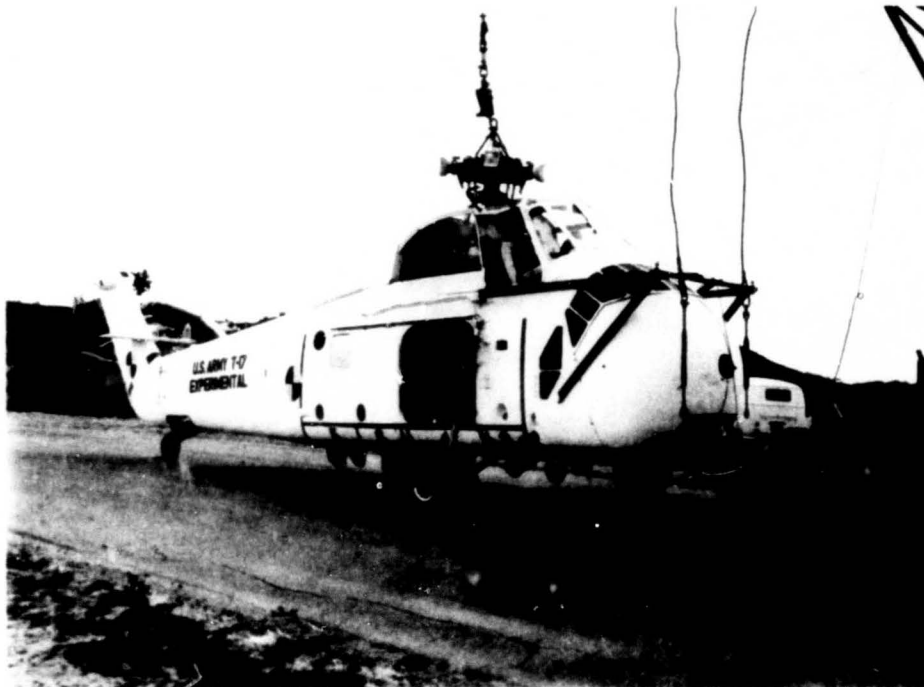
To assure a severe test condition, a rough terrain was simulated by attaching rocks (10 to 14 inches in diameter) to the underside of the fuselage directly beneath each fuel tank. The attachment of these rocks to the bottom of the fuselage is shown in Figure 60, which also shows the locations of the various tanks by number. The impact itself was on a smooth airport taxiway, inasmuch as it was necessary for the crane to move over the impact area prior to release of the aircraft.

Figure 60. CH-34 Aircraft Prior to Test, T-17.

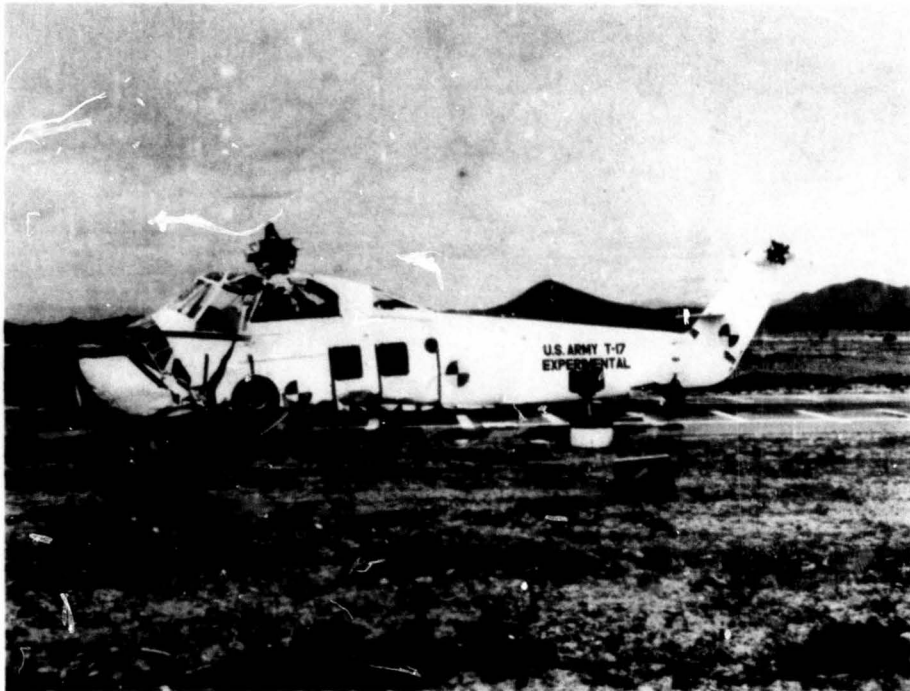
The velocity at impact was 59 feet per second. At impact, the rocks attached to the underside of the fuselage were driven through the aircraft understructure into the tanks, and the underbelly of the aircraft was crushed some 12 to 18 inches, as shown in Figure 61. All except the three "Tough Wall" experimental tanks experienced extensive failure at impact.

Figure 61. Postcrash View, T-17. (During the Impact, the Floor Was Crushed Upward a Distance of 12 to 18 Inches.)

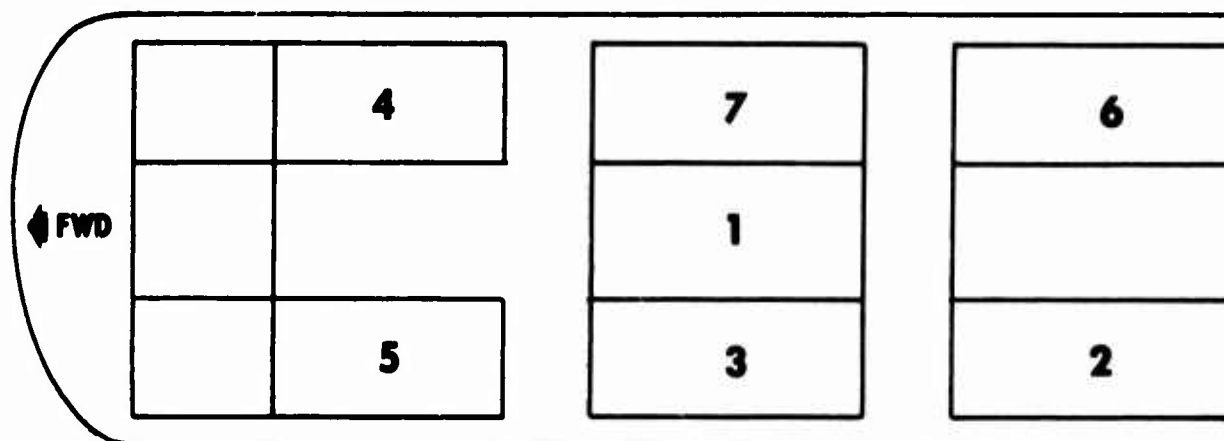
Figure 68. Fuel Cell Type and Location.

Code	Tank	Core	Contents	Tank Construction
1	"Tough Wall"	Hollow	Water	Specimen D, Nylon Cloth/ Polyurethane Resin
2	"Tough Wall"	Honeycomb	Water	Specimen D, Nylon Cloth/ Polyurethane Resin
3	"Fuzzy Wall"	Hollow	Water	Specimen I, Nylon Felt Pad/Crinkl-Core Liner
4	Net	Hollow	Water	1/8-in. Nylon Cord, Nylon Cloth, Crinkl-Core Liner*
5	Firestone A	Open Pore Sponge	Water	Synthetic Cloth/Rubber Like Resin
6	Firestone B	Hollow	Water	Synthetic Cloth/Rubber Like Resin
7	Firestone C	Hollow	Water	Synthetic Cloth/Rubber Like Resin/Polyurethane Coating

* This tank was composed of "Crinkl-Core" liner, forming a liquid-tight inner bag, surrounded with one layer of unimpregnated nylon cloth. The tank was then covered with a 1/8-inch-diameter nylon cord net, built to a 1-inch grid.

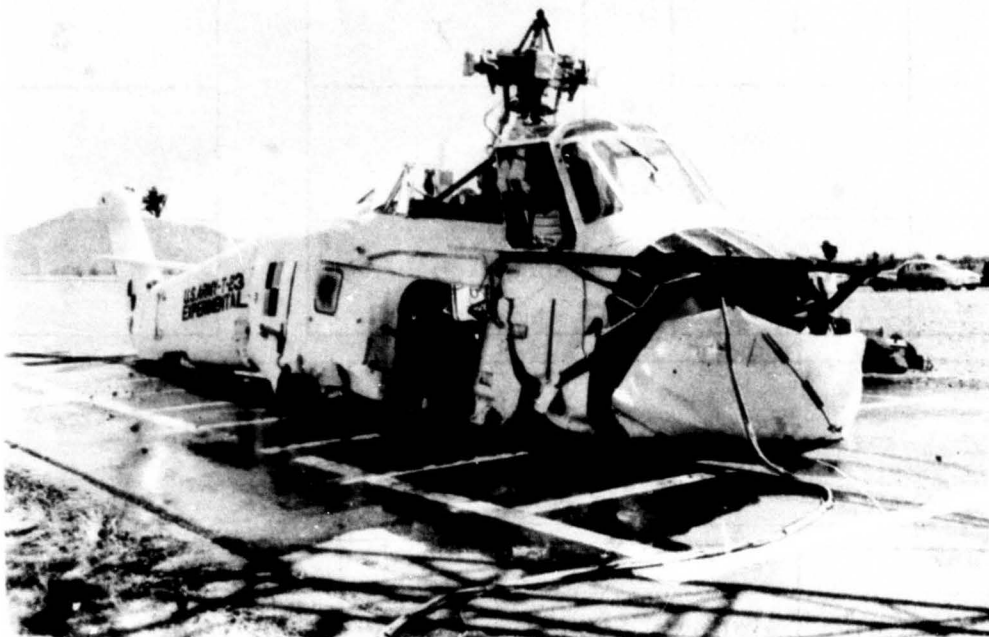
Figure 69. Postcrash View, T-23.

Some damage was experienced with all but one of the tanks installed in the aircraft. Figure 69 shows the aircraft in its final position after the crash. The spillage pattern resulting from the failed tanks is shown in Figure 70. The "Fuzzy Wall" tank was the only tank which did not fail.

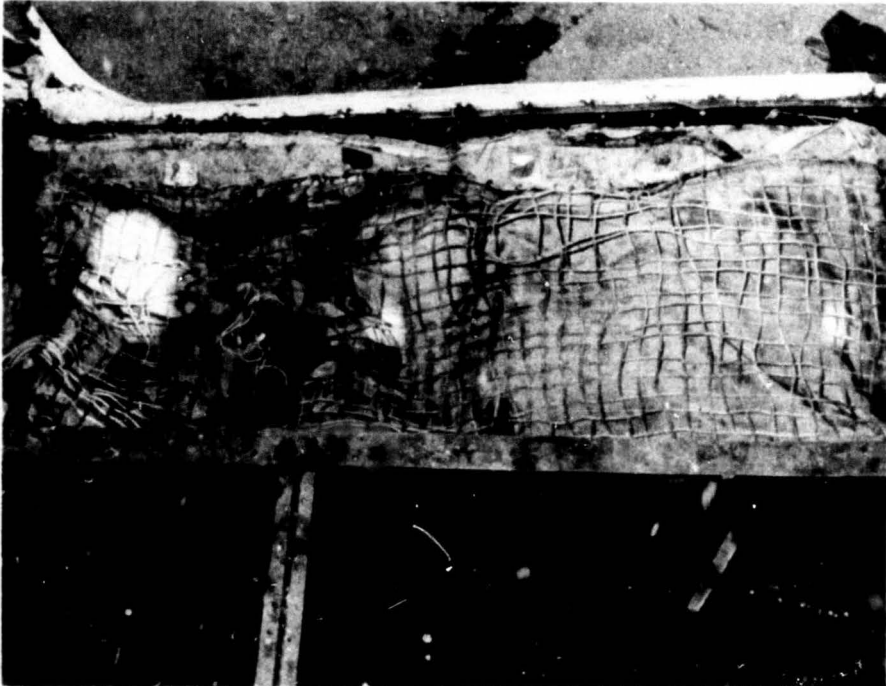
The net tank and the "Tough Wall" honeycomb tank sustained slight damage; however, the leakage was less than 1 gallon per minute. All other tanks sustained massive damage. Figures 71 through 82 show the various tanks before and after the test.

Figure 72. Net Tank - Postcrash, T-23. (View of the Net Tank After the Floor Was Removed.)

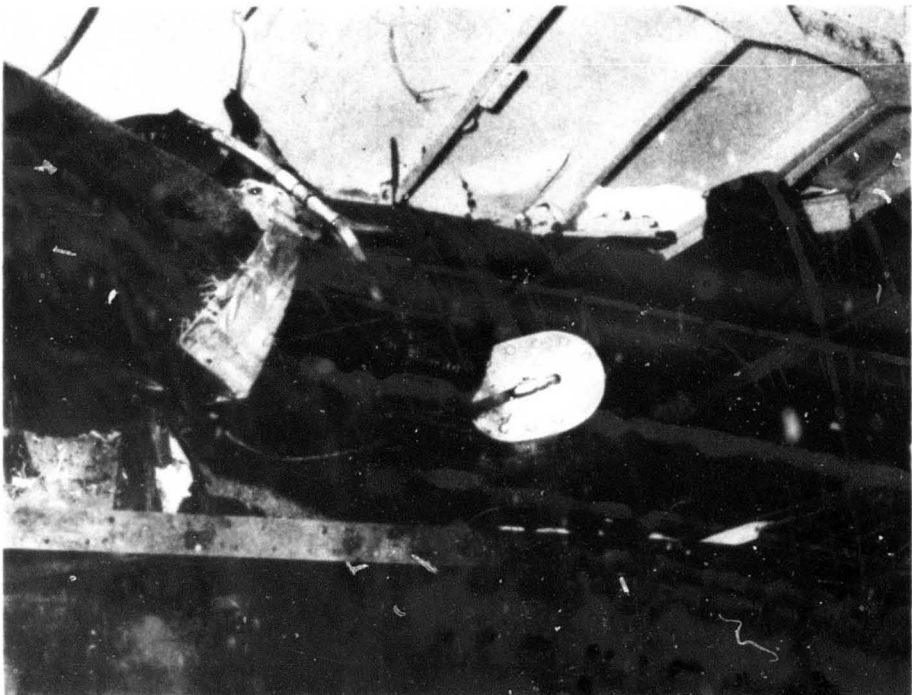
Figure 76. Type A Tank, T-23. (The Sponge-Cored Tank in Location After Floor Removal.)

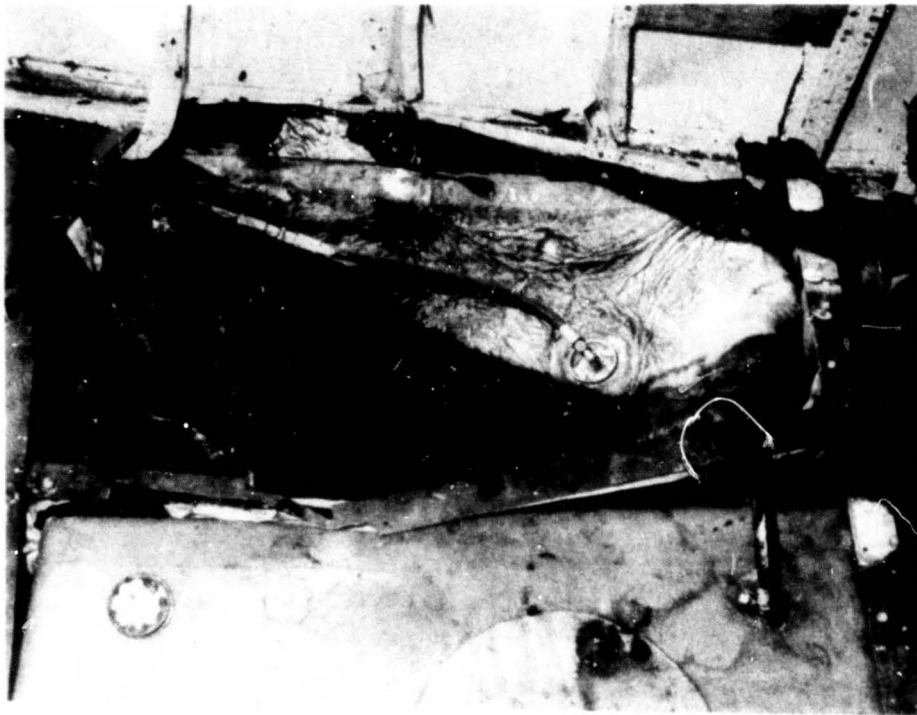
Figure 79. The "Fuzzy Wall" Tank, T-23. (The Nonleaking "Fuzzy Wall" Tank in Location with the Floor Removed.)

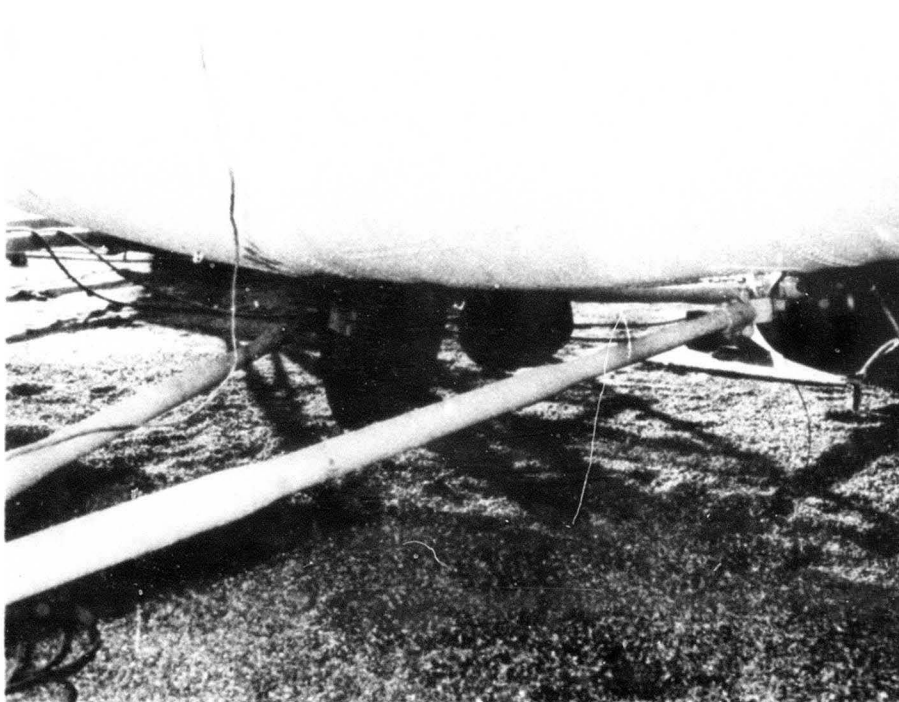
Figure 85. Rough Terrain Environment, T-18. (Rocks Attached to the Underbelly of the Fuselage Simulated a Rough Terrain Type Impact.)

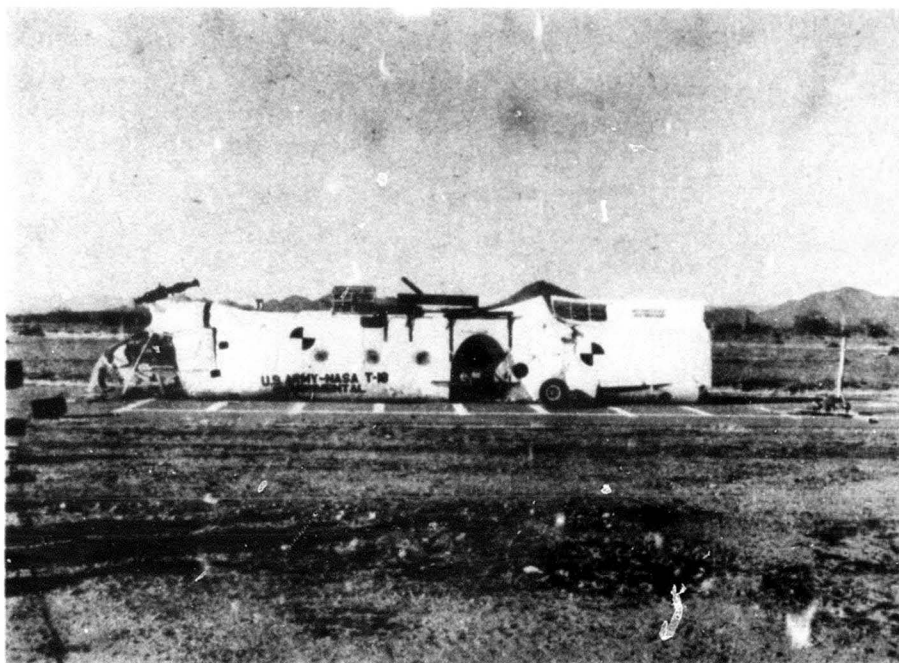
Figure 86. Postcrash View of T-18. (Helicopter Final Resting Position After the 30-Foot Free Fall.)

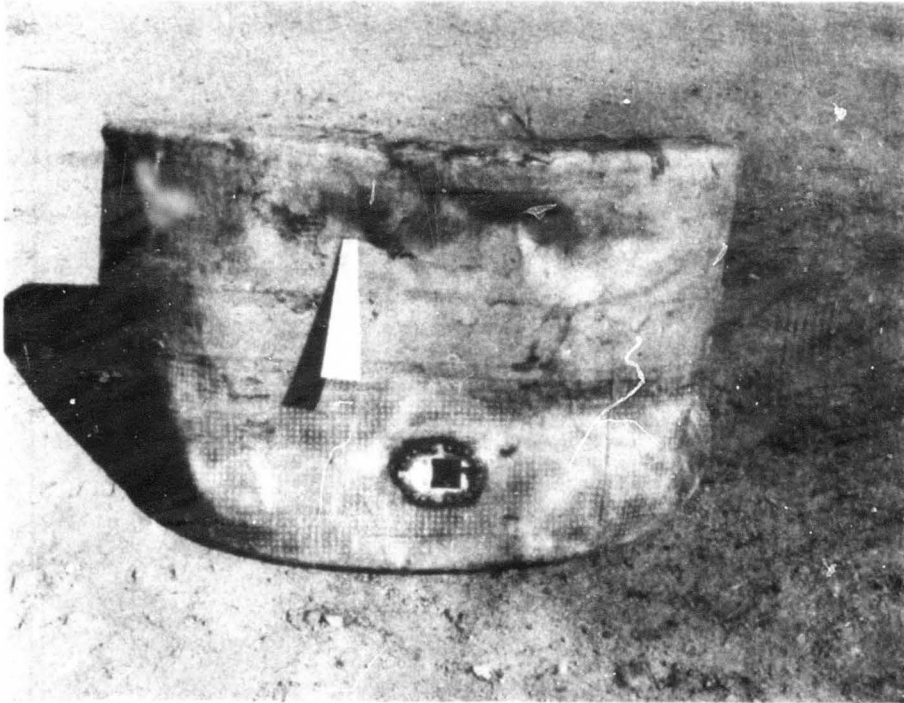
During impact, the tank sustained five small penetrations; three of the penetrations were approximately 1 inch in length, one was approximately 2 inches in length (upper left front corner), and one was approximately 1/8 inch (bottom). The tank is shown in Figure 89 after removal from the aircraft.

Figure 89. CH-21 Tank Cuts. (Pointer Is Inserted into Largest Cut on the Fuel Tank Bottom.)
